Equipment Location Detail	
Full Height Single Turnstile	
DWG	Correct Vs Incorrect Center Rotor Section Installation
DATE	01/23/19
SCALE =	< >
SHEET - 1 OF 1

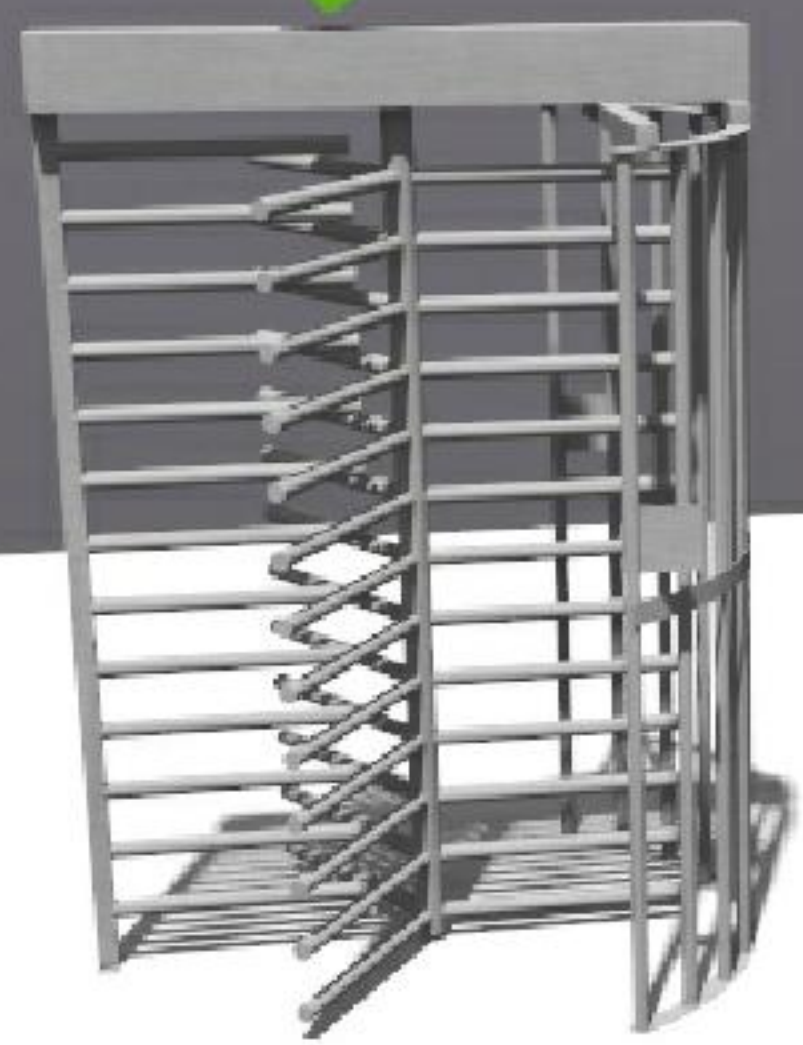
CORRECT  
INSTALLATION

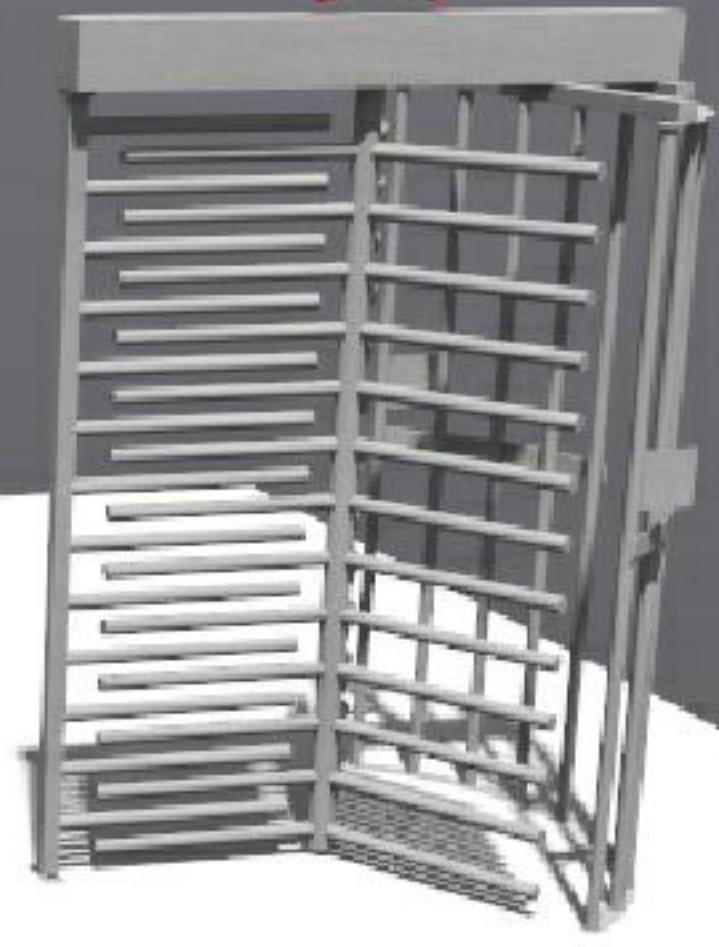
INCORRECT  
INSTALLATION

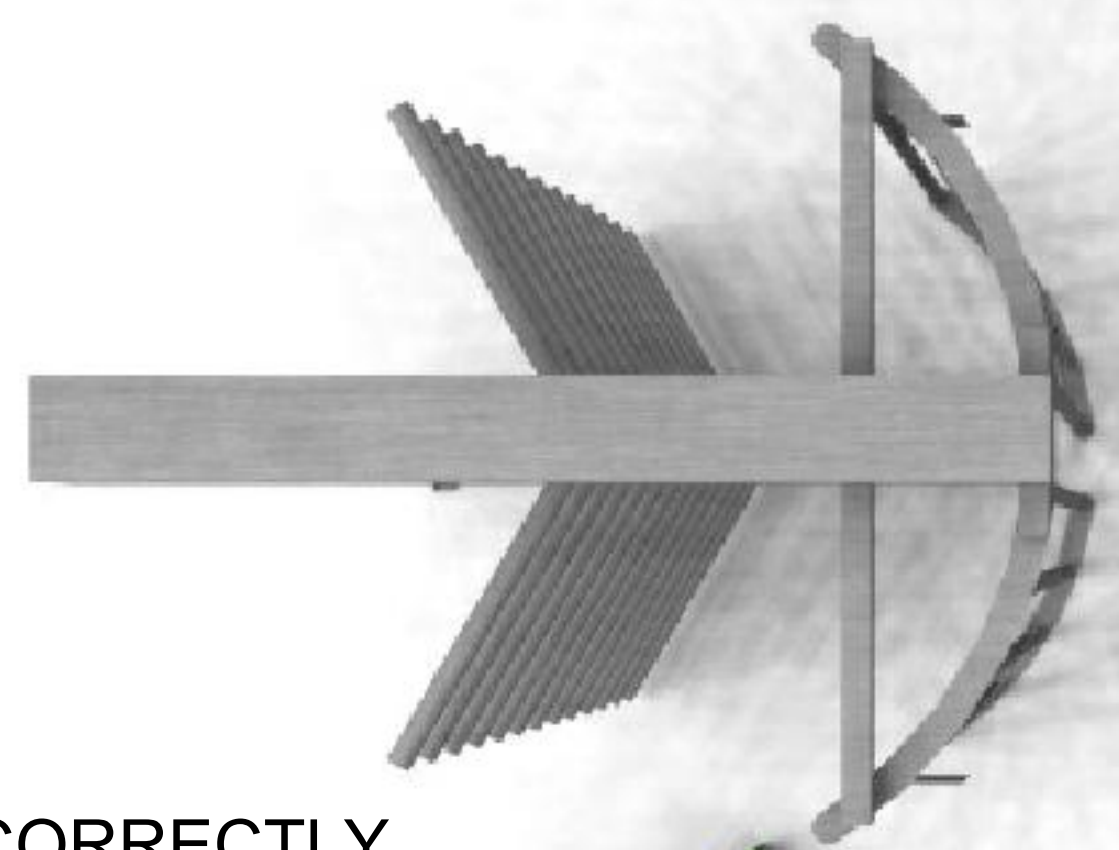
CORRECTLY  
INSTALLED CENTER  
ROTOR SECTION

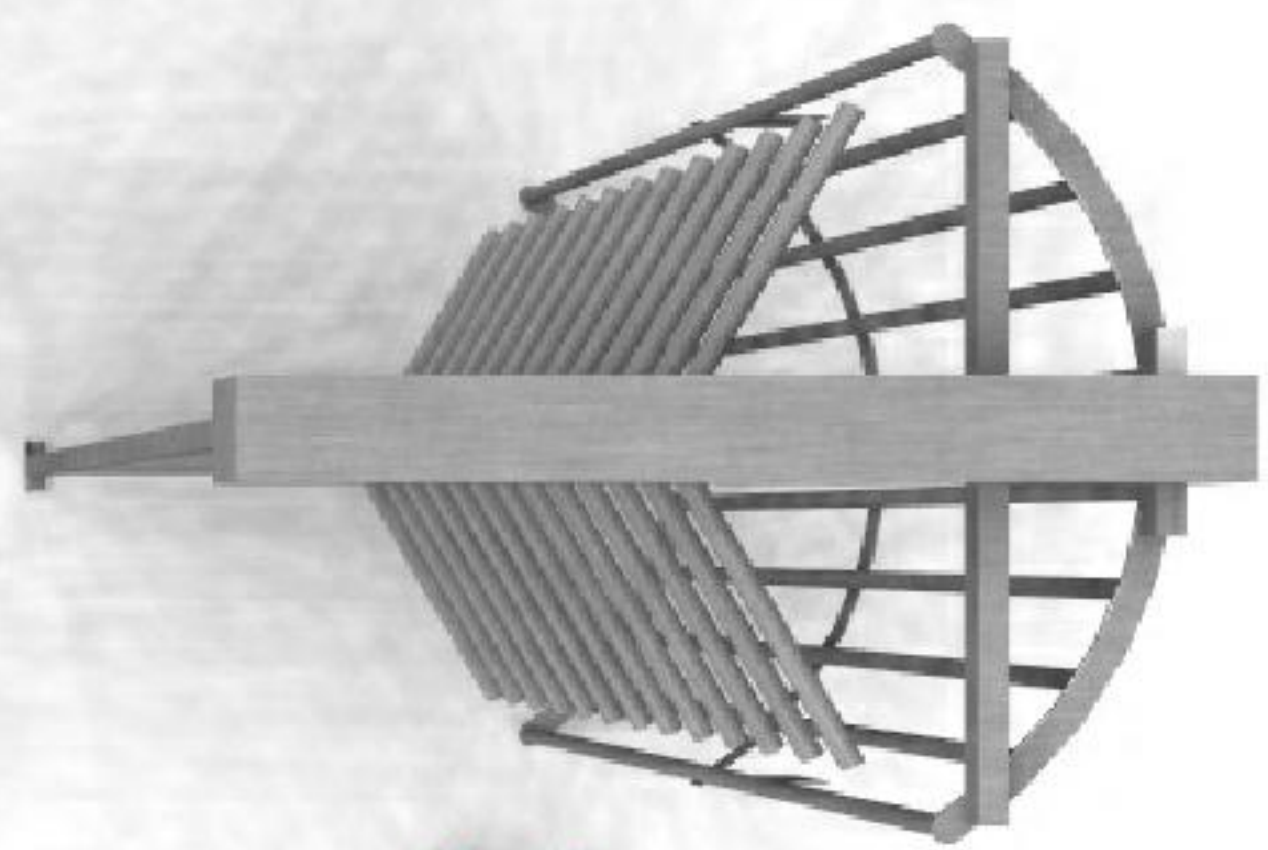
INCORRECTLY  
INSTALLED CENTER  
ROTOR SECTION
